**MURALT WALLS:
VIANE AND
SCHELPHOEK,
NETHERLANDS.**

GPR Investigation of
Voiding below the
Muralt Walls.

FINAL REPORT

MURALT WALLS: VIANE AND SCHELPHOEK, NETHERLANDS

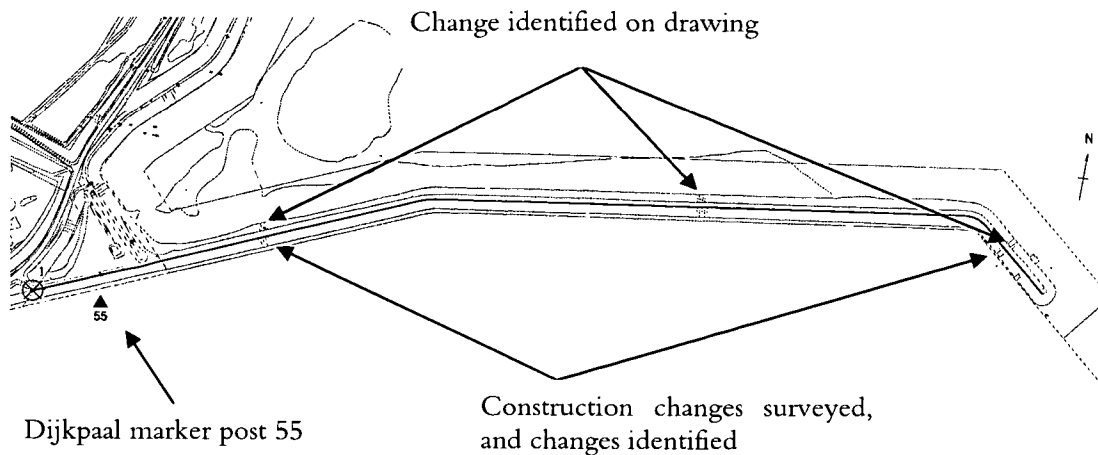
Figure 3: Location plan of Schelphoek West showing locations of construction changes. Green line represents survey area.

The drawing supplied by the client shows three changes in construction along the length of the survey area. Due to heavy vegetation on site, only two of these construction changes were surveyed, and changes in data were identified over both. It is therefore likely that the remaining unsurveyed construction change will be of similar construction to those already surveyed (Appendix A Figure 2). Plate 6, Appendix C shows an example of the surveyed construction change at Dijkpaal 55 +c.1327 m which was also visible on the surface.

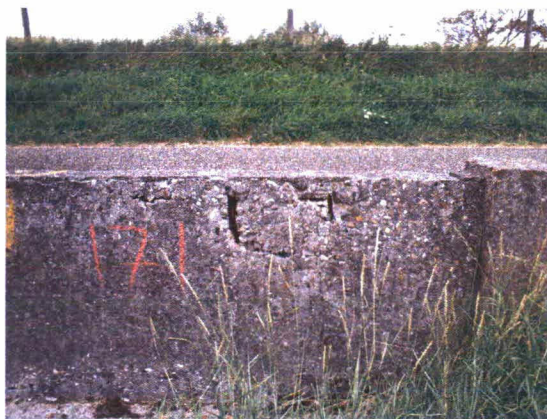
For the majority of the survey area the concrete appeared to be in good condition. In several places, particularly around Dijkpaal No. 329 there was cracking and/or spalling of the concrete and in some places reinforcement bars were exposed on the surface (Appendix C, Plates 1-4).

Plate 1: Viane, Dijkpaal No. 329 + c.63m:
Spalling evident in wall. Reinforcement bars visible.

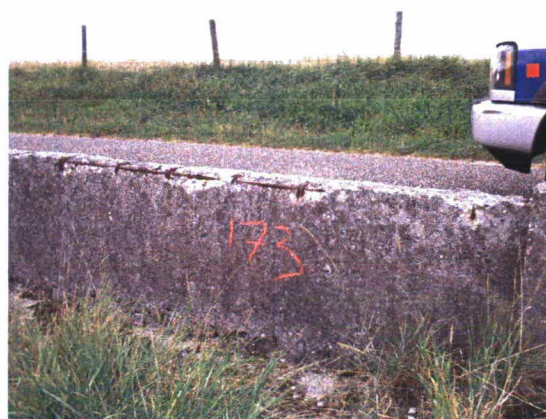
Plate 2: Viane, Dijkpaal No. 329 + c.55.5m:
Reinforcement bars visible along top of wall.

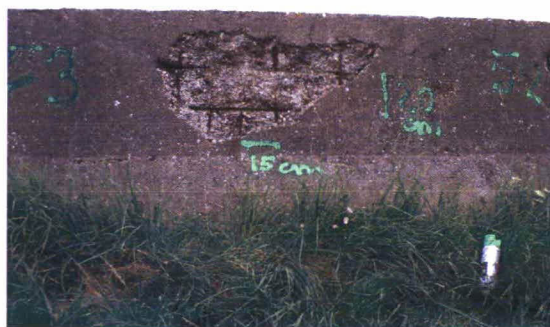
Plate 3: Viane, Dijkpaal No. 333 + c.54m:
Large area of spalling in wall. Reinforcement visible. Approximate dimensions marked on wall.

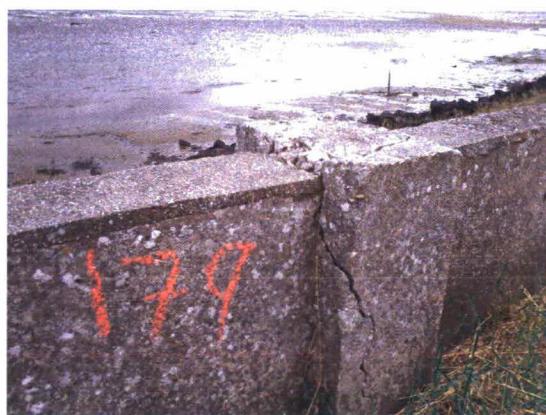
Plate 4: Viane, Dijkpaal No. 329 + 36.85m:
Cracking in post.

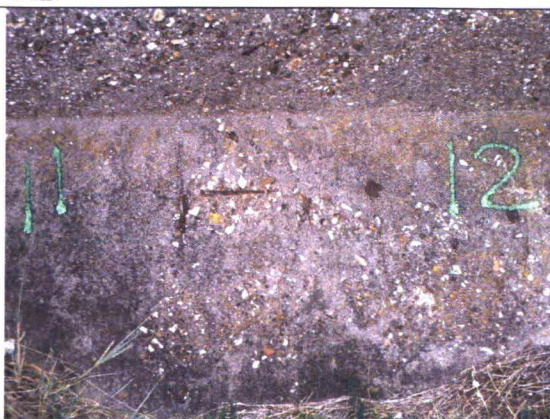
Large areas of concrete were obscured by vegetation which compromised the visual survey. However several of areas near the start of the survey (Dijkpaal 55) appeared to be in poorer condition (Appendix C, Plates 5-7).

Plate 5: Schelphoek, Dijkpaal No. 55 - c.67m:
Reinforcement visible on concrete slope.

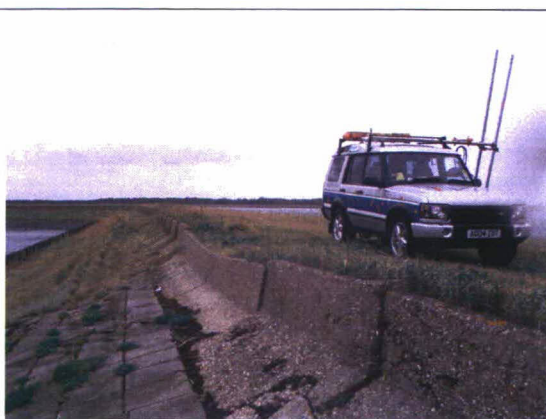
Plate 6: Schelphoek, Dijkpaal No. 55 +c.1327m
Change in construction at end of dyke (near survey limit) at Schelphoek West.

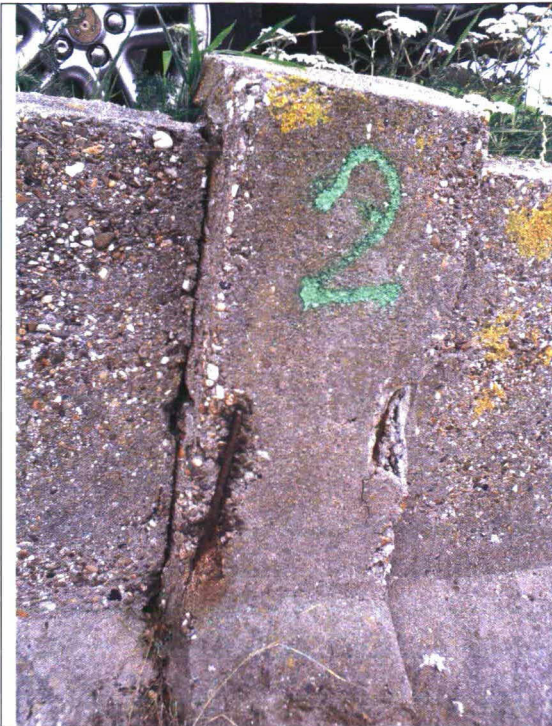
Plate 7: Schelphoek, Dijkpaal No. 55 –
c.90m:
Reinforcement visible on post.

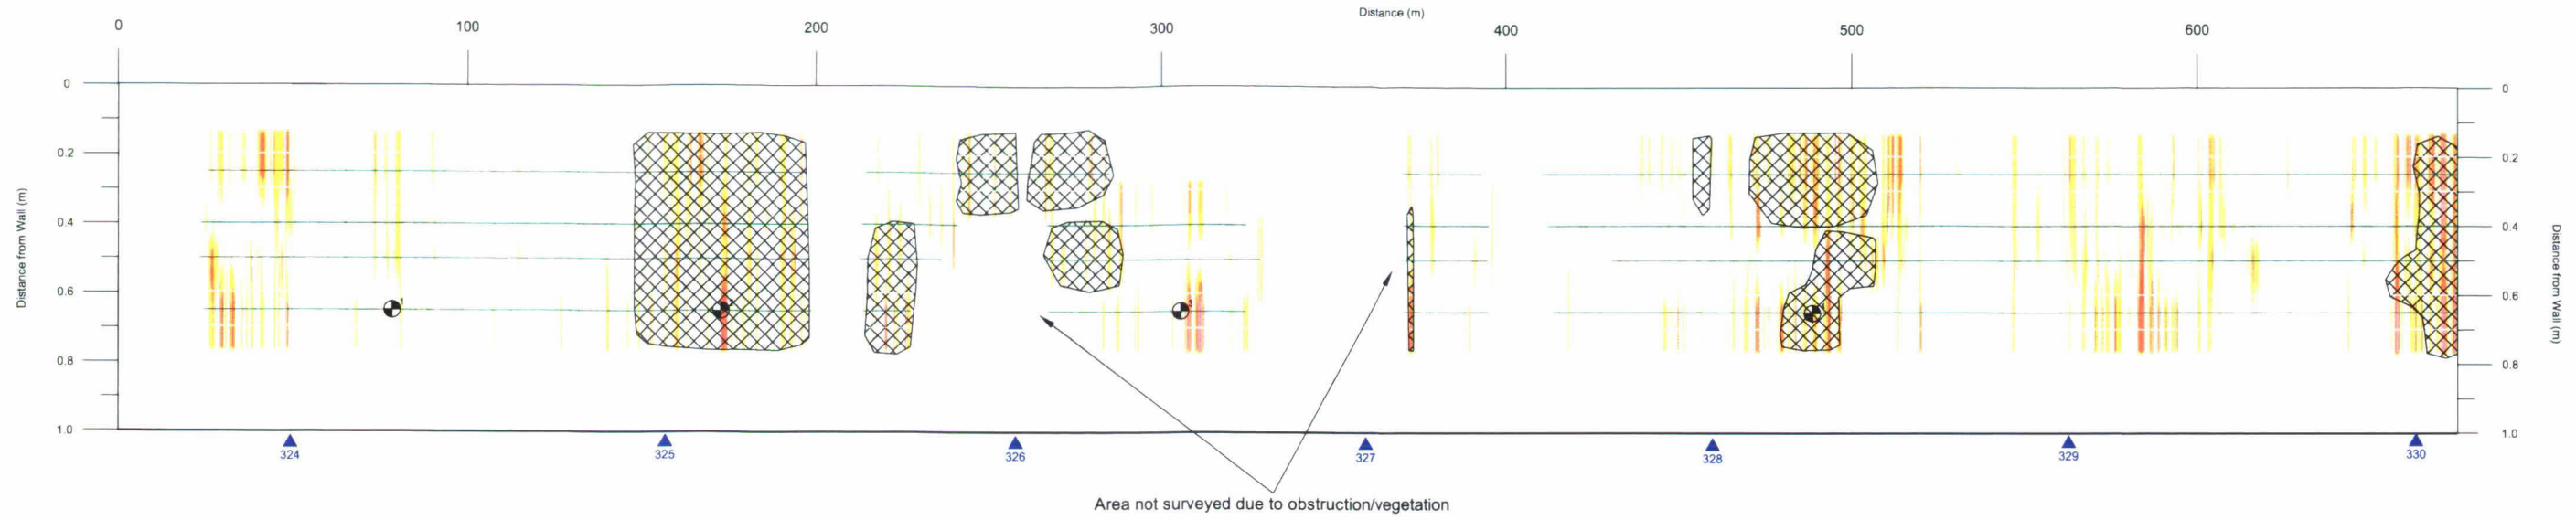
FIGURE 1: VIANE SECTION 1 DIJKPAAL 324 to DIJKPAAL 330

In general, section 1 appears to be in good condition with a number of smaller areas of potential voiding. Section 2 generally appears to show more evidence of voiding throughout.

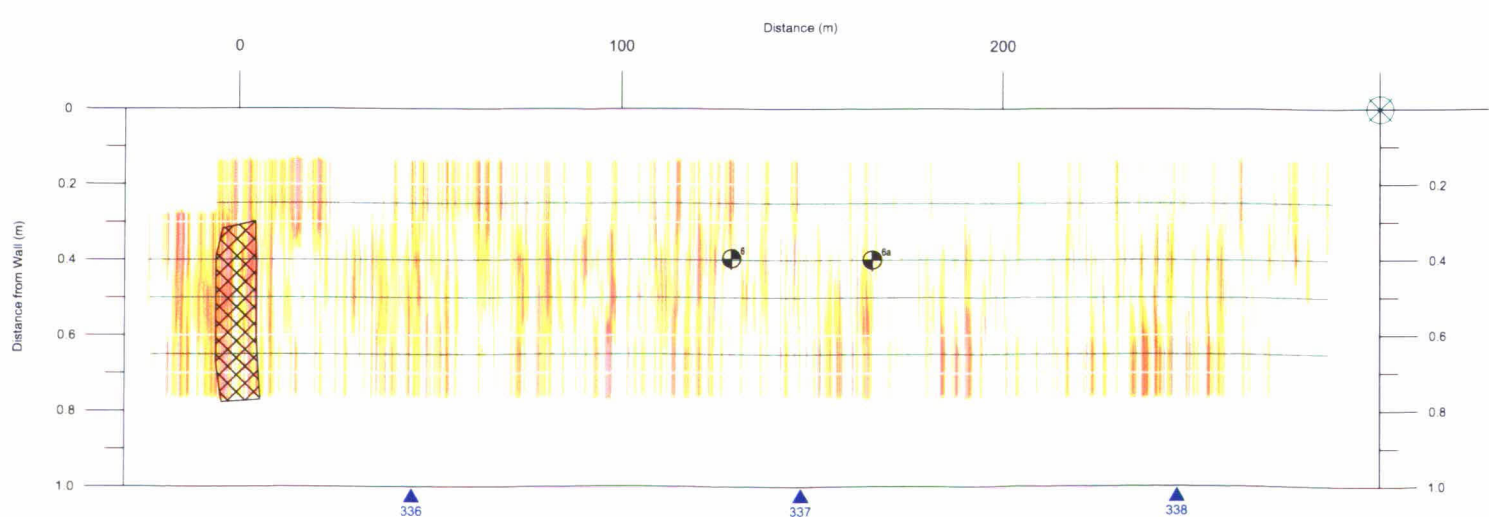
FIGURE 3: VIANE SECTION 2 DIJKPAAL 336 to DIJKPAAL 338

The only location where voiding has been identified by coring is at 337 + 18.5 m, however similar areas of high amplitude response persist along much of section 2. Several large areas of concern exist along section 2 and it is recommended that any further intrusive testing should be concentrated in these areas. In addition to the areas in section 2, 3No. large areas of concern exist in section 1.
