Memo

7 mei 2015

1210179-000-ZKS-0004

On the relationship between dike revetments and ecology: lessons learned for design and follow-up monitoring for asphalt covered locations

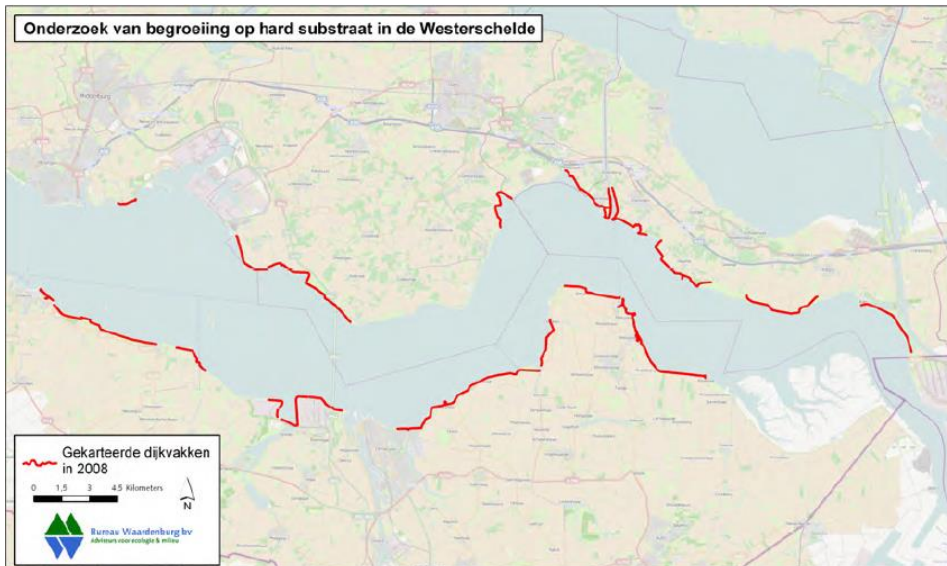
Figure 3.1 Monitored hard substrate along the Western Scheldt coastline in 1990 and 2008 (Meijer et al, 2011).

One of the larger inventories that have been performed is the inventory of the weeds along the dikes of the Western Scheldt in both 1990 and 2008 by Meijer et al (2011), Figure 3.1. This monitoring was based on the community typology work of Meijer & Van Beek (1988) and has qualified vegetation on different substrates in 1990 and 2008. Between 1990 and 2008 much of the patchy revetments on dikes have been replaced (Meijer et al. 2011). Performed inventories have made a link to the substrate on which the communities where found. Along with that, some comments are made on design which will be included in Table 4.1.
