**MURALT WALLS:
VIANE AND
SCHELPHOEK,
NETHERLANDS.**

GPR Investigation of
Voiding below the
Muralt Walls.

FINAL REPORT

MURALT WALLS: VIANE AND SCHELPHOEK, NETHERLANDS

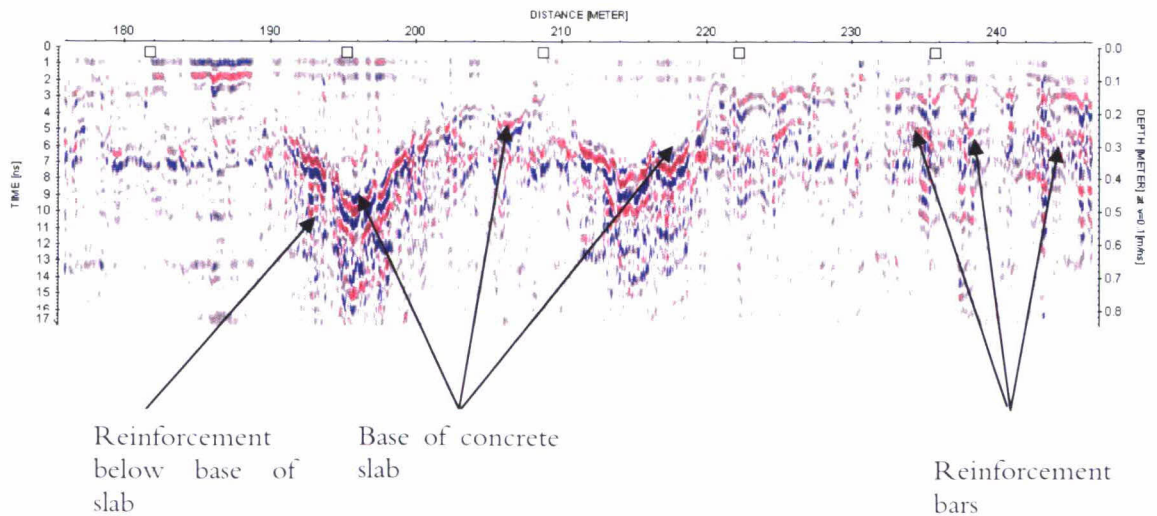
Figure 2: Longitudinal Profile (0.5m) at Schelphoek West over Construction Changes between Dijkpaal 55+c.175m and c.245m, 900MHz antenna

The drawing supplied by the client shows three changes in construction along the length of the survey area. Due to heavy vegetation on site, only two of these construction changes were surveyed, and changes in data were identified over both. It is therefore likely that the remaining unsurveyed construction change will be of similar construction to those already surveyed (Appendix A Figure 2). Plate 6, Appendix C shows an example of the surveyed construction change at Dijkpaal 55 +c.1327 m which was also visible on the surface.
